Subject: Inspection of the Garfield County's John's Valley Landfill on October 1,

2008

SOLID WASTE FACILITY INSPECTION REPORT CHECKLIST

Facility Name John's Valley Class I Landfill County Garfield						
Location						
Inspection Date 10/1/08 Time In 2:30 pm Time Out 3:00 pm						
Routine Oversight						
Announced Unannounced Weather Conditions Sunny and nice						
Inspection Goal Compliance with the State Solid Waste Rules and there Permit						
Facility Contact Brian Bremner						
Participants						
FOLLOW UP INSPECTION NEEDED Yes No Recommended Follow Up Date						
(X - indicates items reviewed)						
. PRE-INSPECTION REVIEW						
✓ 1.1 Permit Review ✓ 2.13 Leachate Collection System						
Need to amend the present permit in order to address the addition Looked ok, see photos of the new lined cell.						
of a Construction and Demolition Waste cell being used on site.

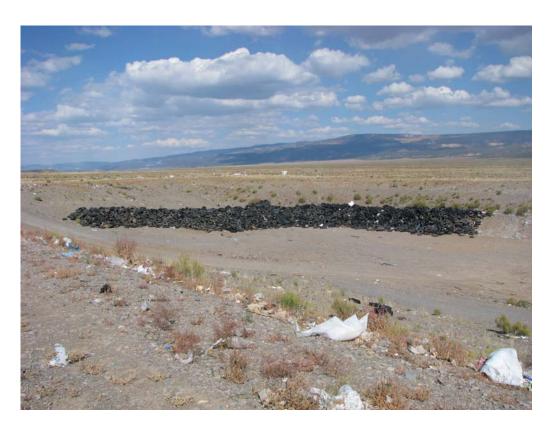
7.3 Hazardous Waste	
The Table does it uses	9.11 Other
7.4 Infectious Waste	
1.4 infectious waste	
N	10. MONITORING / SAMPLING / ANALYSIS RECORDS
7.5 Tires	
The two tire piles are quite large and have been mentioned in	☐ 10.1 Explosive Gas Monitoring
previous inspection reports written by Jeff Emmons. see attached	
photos of the tire piles.	☐ 10.2 Leachate Sampling & Treatment
☐ 7.6 Dead Animals	
Put into the working face and cover immediately

Tire pile on the Northeastern side of the landfill.

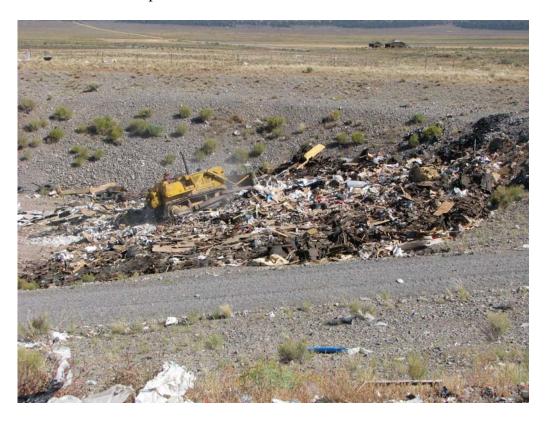
7.7 Asbestos	Need a approved written ground water sampling plan.
	10.4 Other
☐ 7.8 Bulky Waste	10.4 Other
We need a written plan for the new C&D cell east of the present	
	11 CDECIAL WACEE DECORDS
MSW cell. See attached photos.	11. SPECIAL WASTE RECORDS

C&D Cell located just east of the present lined MSW cell.

- The Construction and Demolition Waste cell that is being used on the east end of the landfill needs to have a written and approved plan prior to using the cell. Please submit an amendment to the present permit within 30-days from the receipt of this letter.
- A written Groundwater Monitoring Plan needs to be submitted to our office for approval within 30-days from the receipt of this letter.

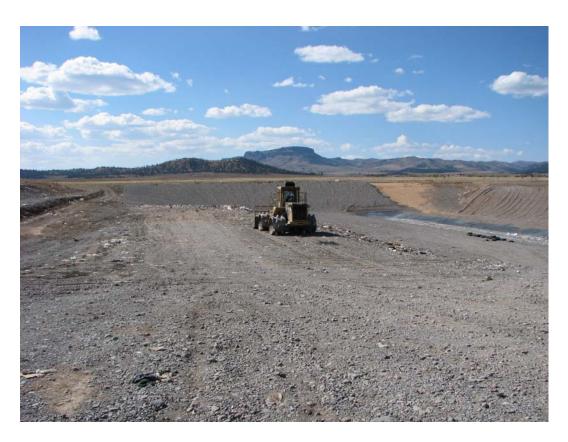
The working face and lift of the new lined landfill cell

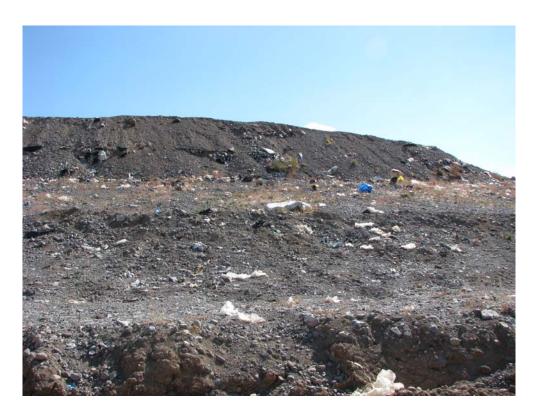
Looking south towards the old working face prior to the opening of the new lined cell.

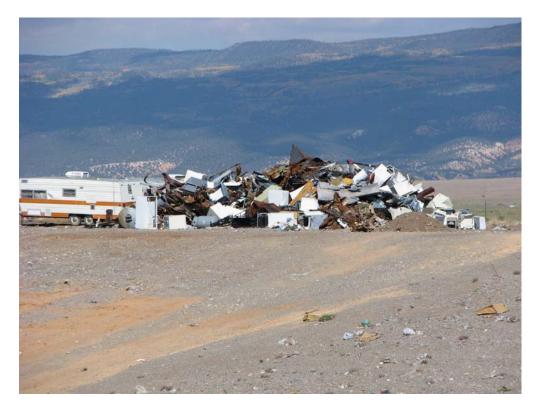
Metal recycling pile

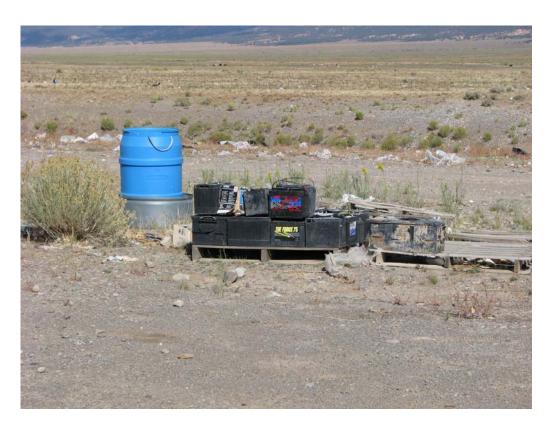
Used battery storage

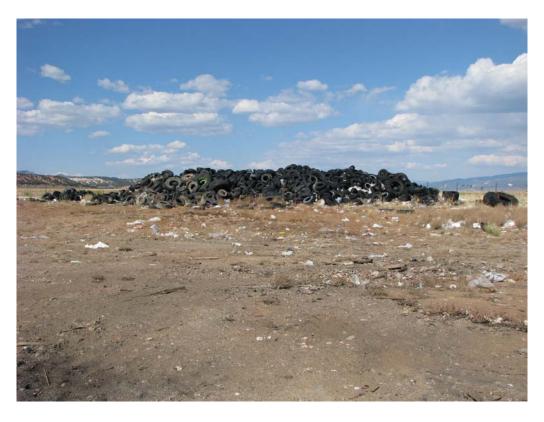
Second tire pile on the north end of the landfill
